**Schroud Realty Group
LPC# 0316555112
ILN 000 505 540
Cook County
SF/HRS**

CERCLA Site Inspection

Title: CERCLA Site Investigation for Schroud Realty Group

February 8, 2017

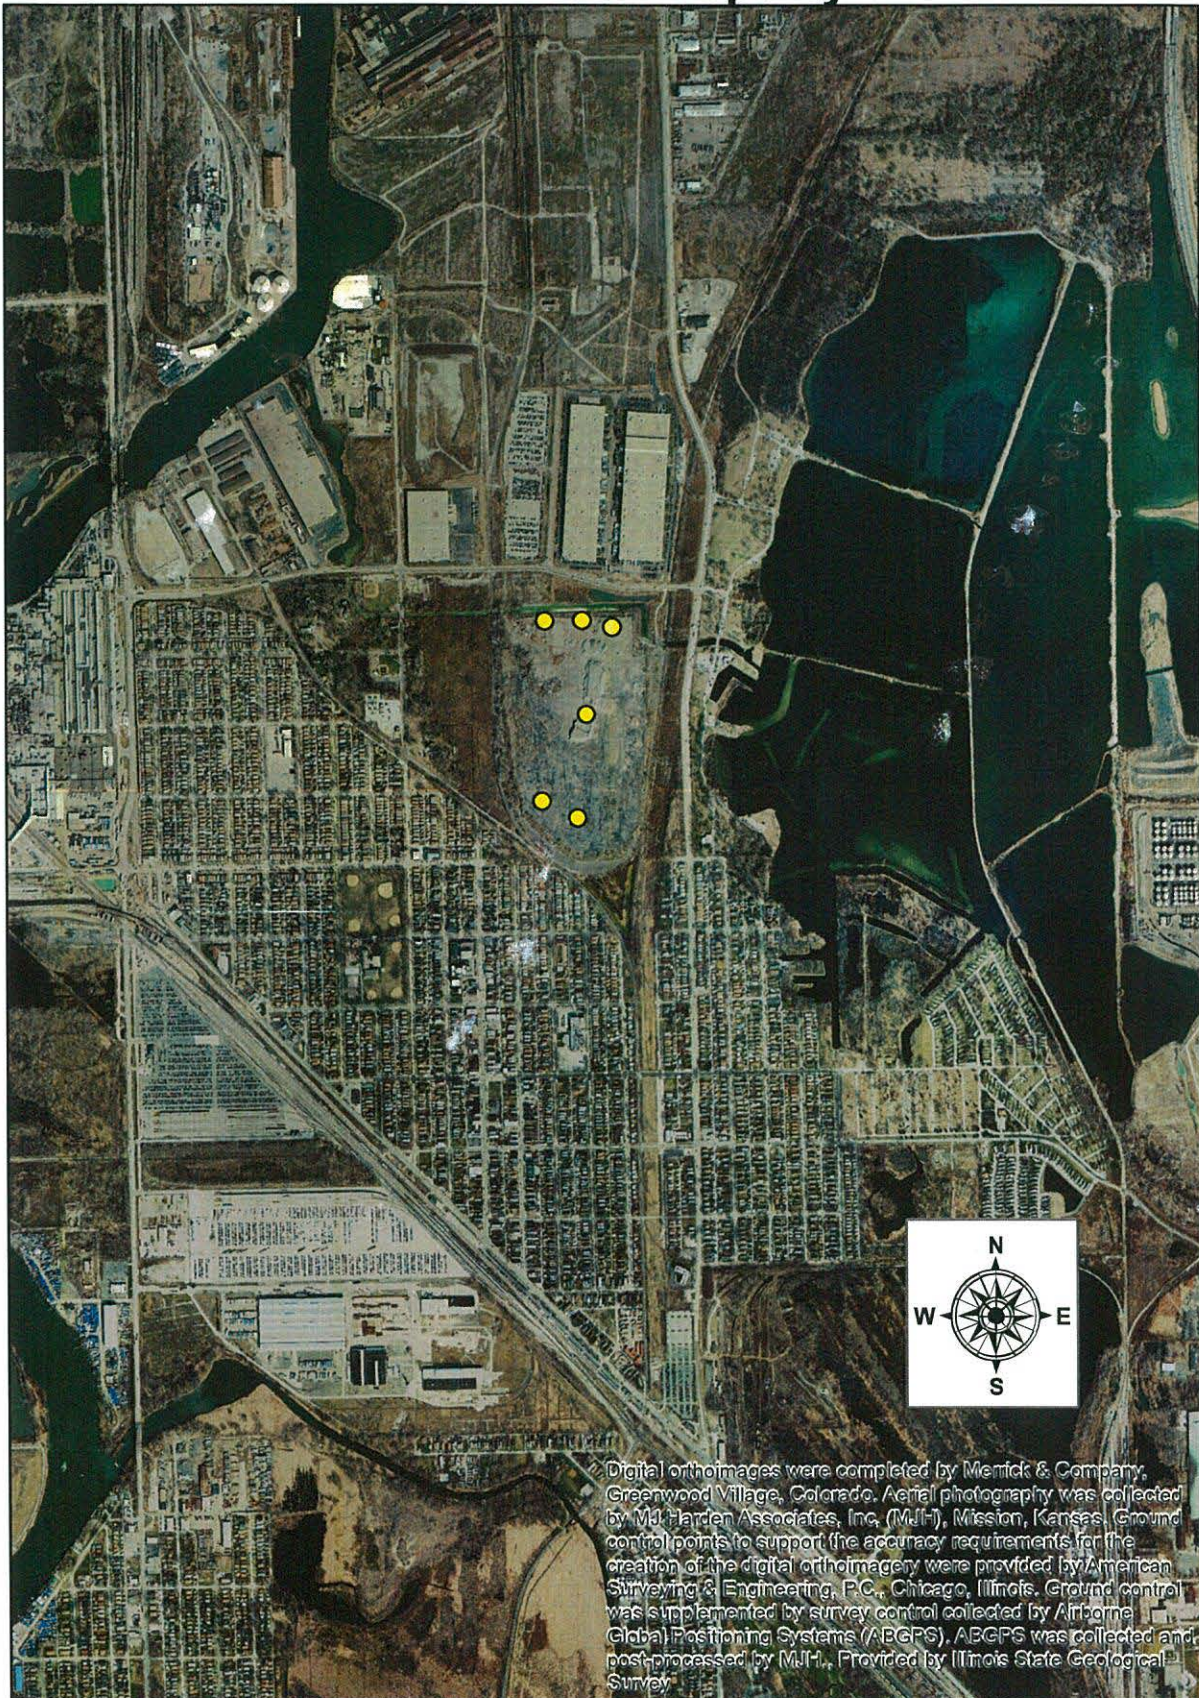
Figure 3
Monitoring Wells
Schroud Property

No groundwater was collected during the Site Inspection. There are a total of six monitoring wells located on the Schroud Site, but none were sampled during the SI (Figure 3). It appeared that the wells were installed some time ago and had either been compromised or were no longer in working condition due to damage. The City of Chicago utilizes drinking water from Lake Michigan and has a groundwater ordinance stating that no well in the city shall be used for drinking purposes; therefore groundwater was not collected during the SI.

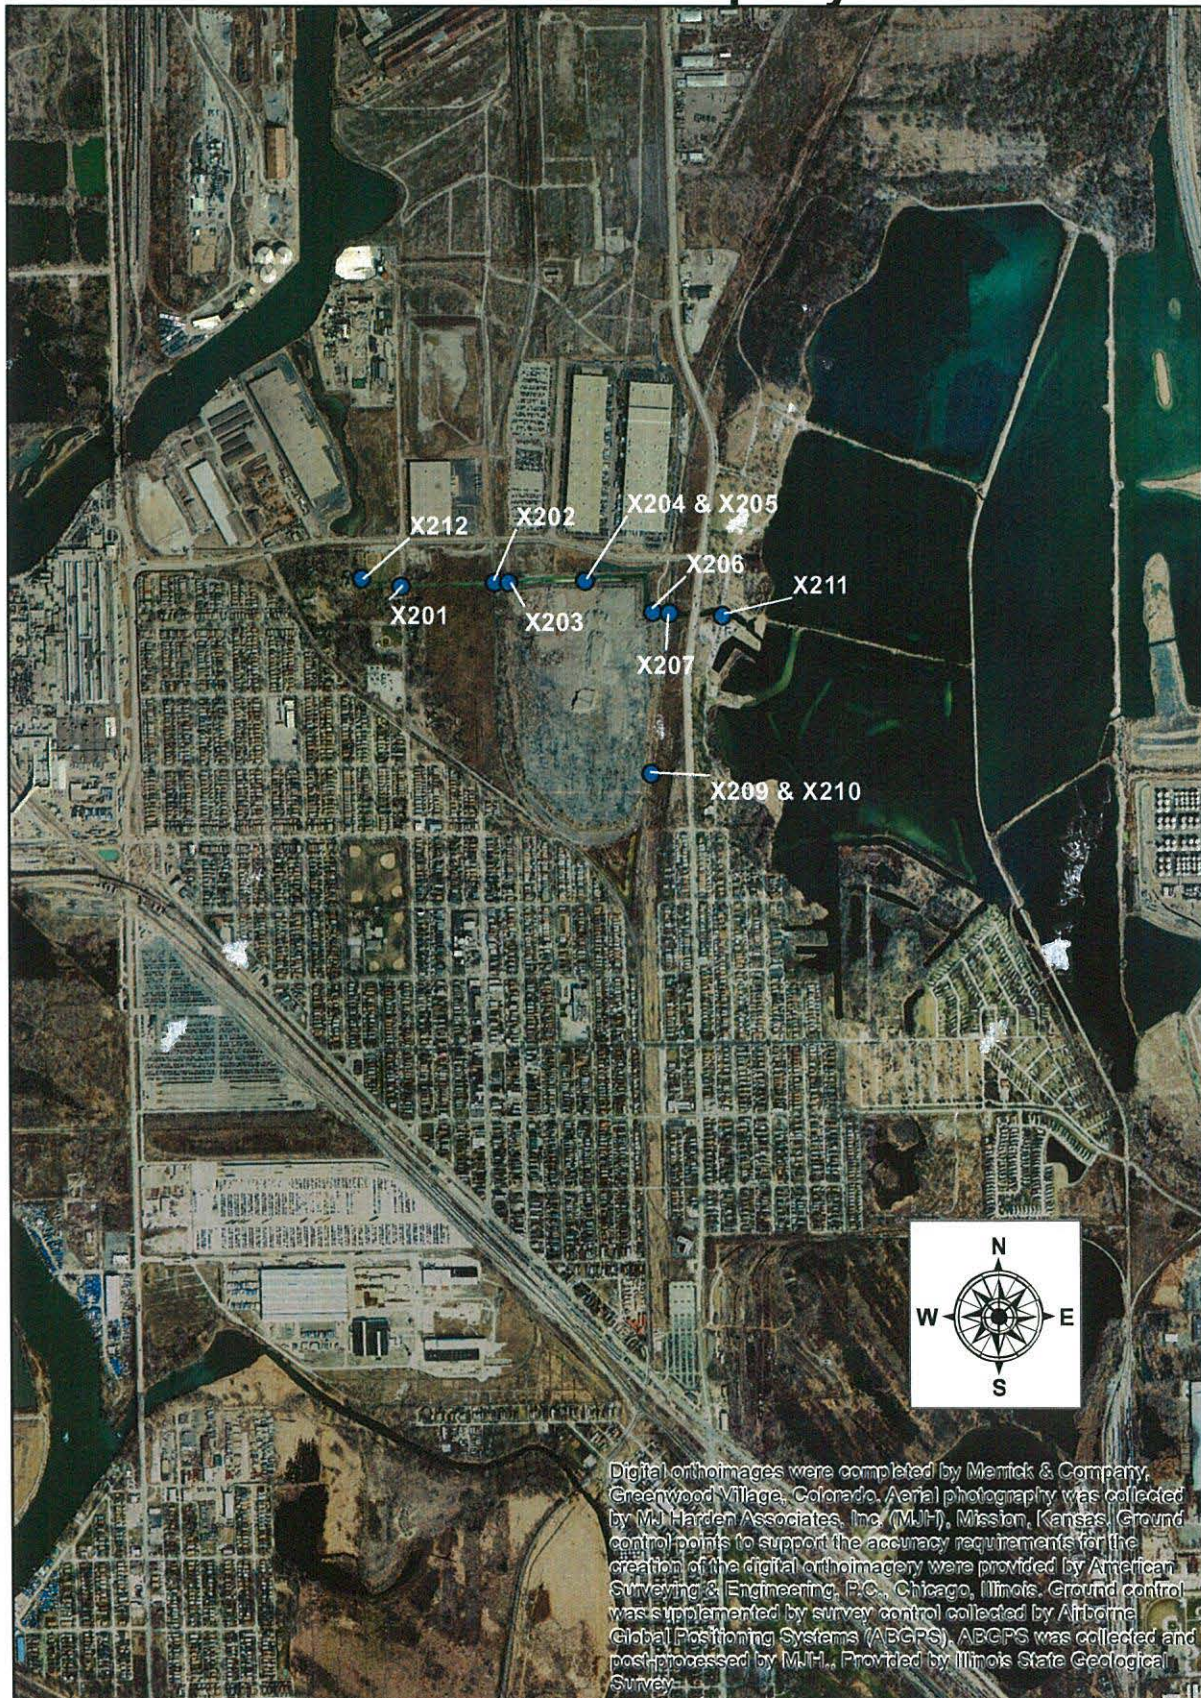
Figure 4
Sediment Samples
Schroud Property

Table 4 summarizes the sediment samples collected from Indian Creek which runs through the northern portion of the Schroud Site. Indian Creek was evaluated to document impact to the creek from activities that took place on the Schroud Site. There were a total of 11 sediment samples collected from nine different locations. All sediment sample depth and description can be found in Table 1. The sediment samples were analyzed for hexavalent chromium, total metals, cyanide, and mercury although not all samples were analyzed for hexavalent chromium (Table 4). There were 20 metals detected in the sediments above three times background or above a removal action level. Sample X111 was used as the background sample.

The slag material slopes towards Indian Creek on the northern end of the pile. The sediment in Indian Creek along the northern perimeter of the Schroud Site is white and has high concentrations of calcium. Sample X203-X206 were collected along the perimeter of the Schroud site and all had very high levels of calcium. Calcium carbonate is a common byproduct in steel slag. In addition to the high calcium levels, the pH was also high in the creek along the perimeter of the site. During the SI, there were a number of dead fish observed in the water along the northern perimeter of the site in Indian Creek. Indian Creek is known to have salmon and trout populations. The pH levels of the creek were approximately 11.5 -12 using a field based pH detector.

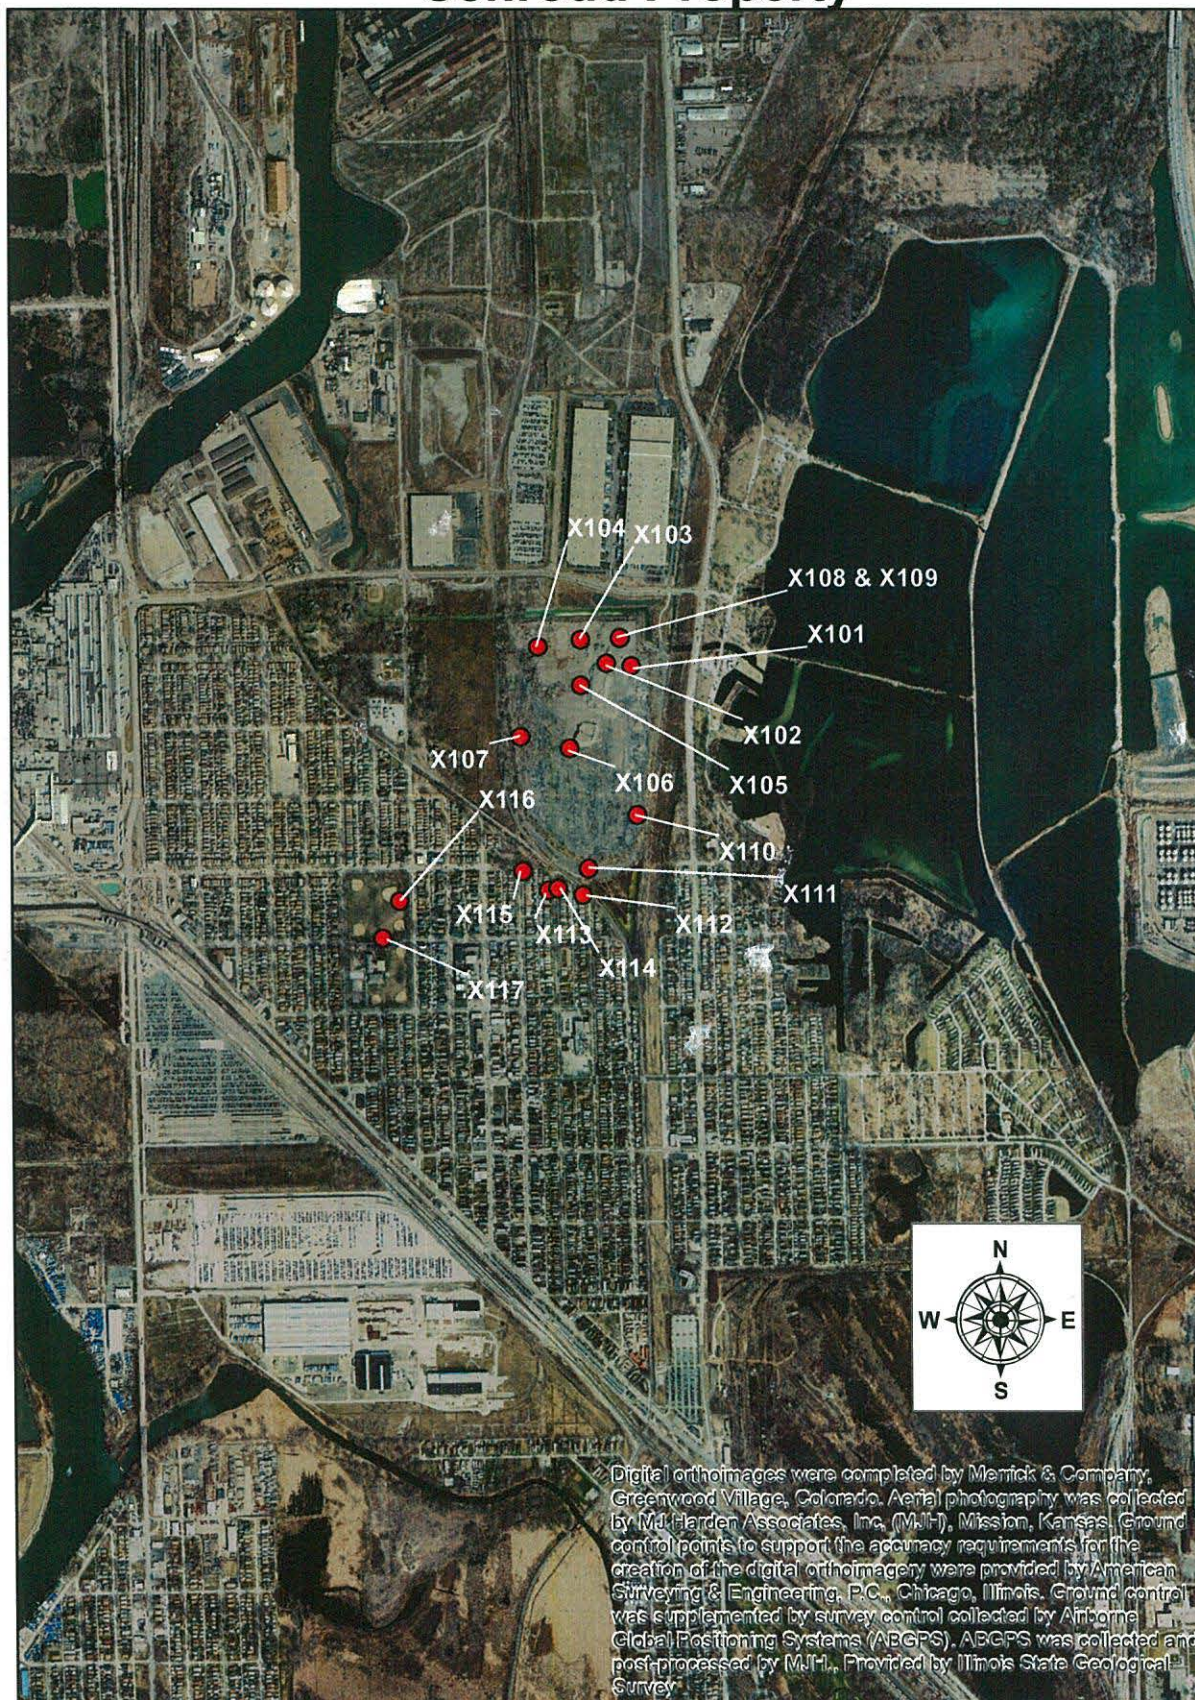
Figure 5
Soil Samples
Schroud Property

There were ten soil samples collected from the Schroud Site during the SI (X101-X111). In addition, there were four residential soil samples collected (X112 – X115) and two background soil samples collected (X116-X117). The soil sample locations can be found in Figure 5 and soil sample descriptions can be found in Table 1. All soil samples collected from the Schroud Site were collected from potential source material which included the slag material that covers approximately 67 seven acres and is approximately 20 feet deep over the entire property. All samples were analyzed for total metals, cyanide, mercury, and hexavalent chromium and can be found in Table 3. Some samples were also analyzed for TCLP metals and can be found in Table 2.

All soil samples collected on the Schroud Site met the criteria for an observed release by being above three times background (Figure 5). Results which met observed release criteria are highlighted in bold in Table 3. Background and Removal Management Levels can be found in Table 3. All samples depths were collected within the top two feet except for sample X203. Sample depths can be found in Table 1.

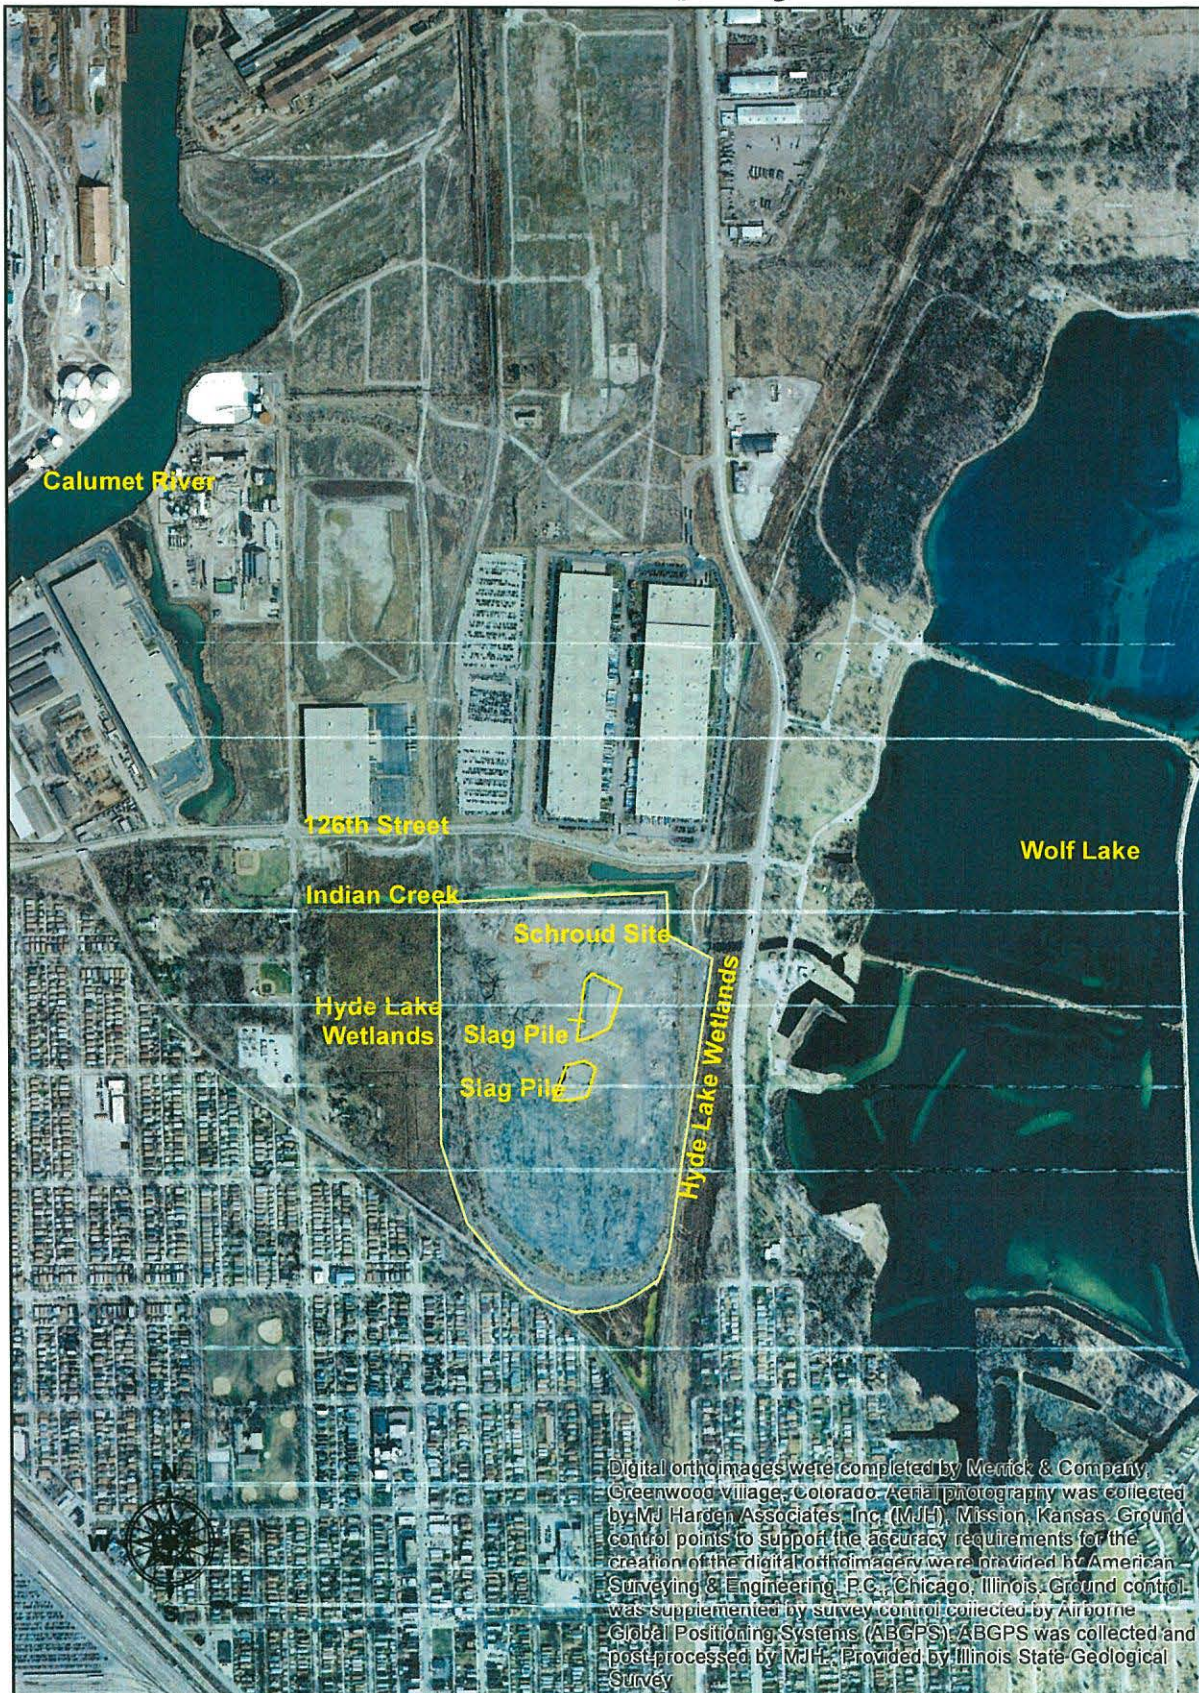
Figure 8 Republic Steel

Republic/LTV Steel facility was located approximately one mile north on 118th Street and was adjacent to the Calumet River (Figure 8). Slag was hauled from the Republic facility to the Schroud Site; slag hauling continued once LTV Steel purchased Republic Steel in the early 1980's (Carnow, Conibear & Assoc.). In the center of the property are two large piles of waste. Dozens of smaller slag piles are located throughout the site. Slag dumping is estimated to have occurred from 1951-1977 (Carnow, Conibear & Assoc.). The larger piles of slag are approximately 30 feet in height. In addition to the piles, slag covers the ground over the majority of the site and there are no buildings located on-site. Prior investigations have indicated that there are elevated lead, manganese, and chromium levels in the soil.

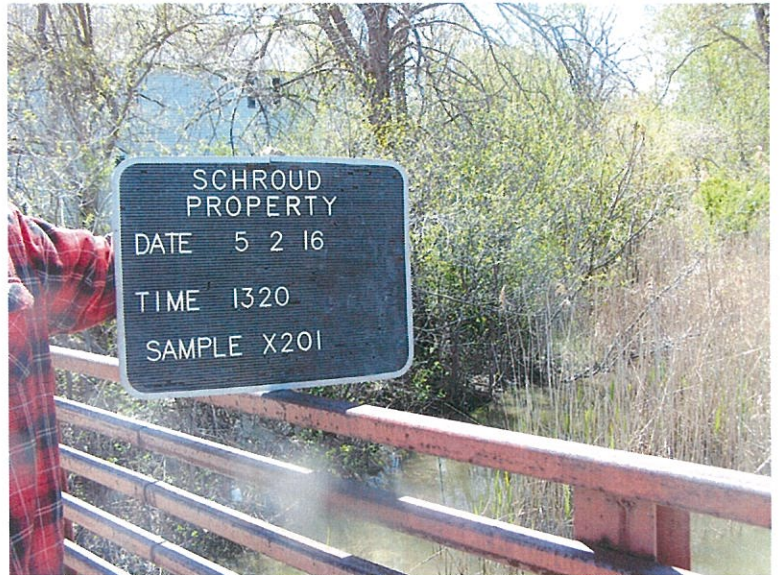
COMMENTS: X201 was collected from the middle of Indian Creek on the west side of the bridge. Material appeared to look like slag fines.

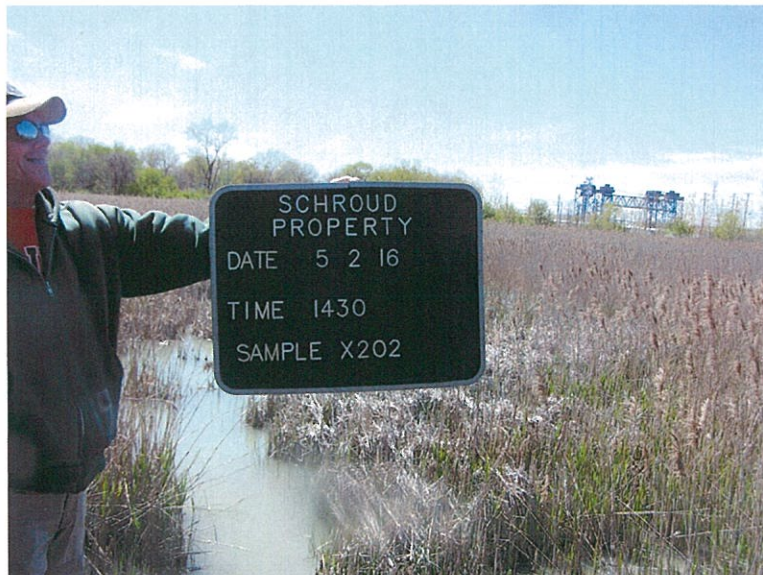
COMMENTS: X202 was collected from the west side of the railroad bridge from 1 foot into sediment. Sediment consisted of about a 1 inch white sediment layer then grayish black for the remainder of the sample.

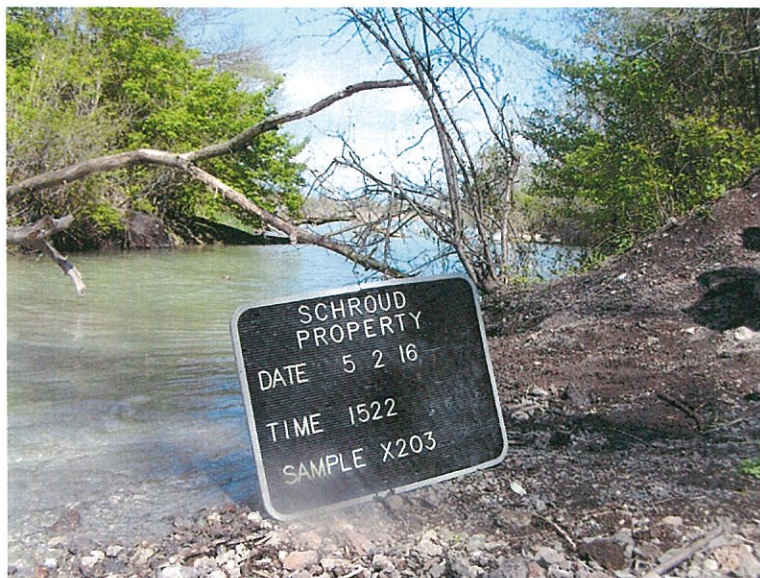
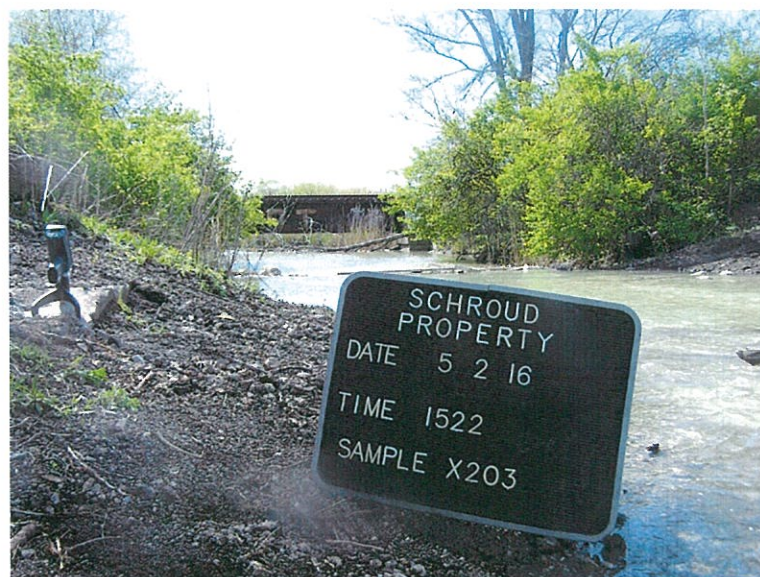
COMMENTS: X203 on south side of Indian Creek along the perimeter of the Schroud Property. Brownish sandy gravelly material. Collected 6 inches into sediment.

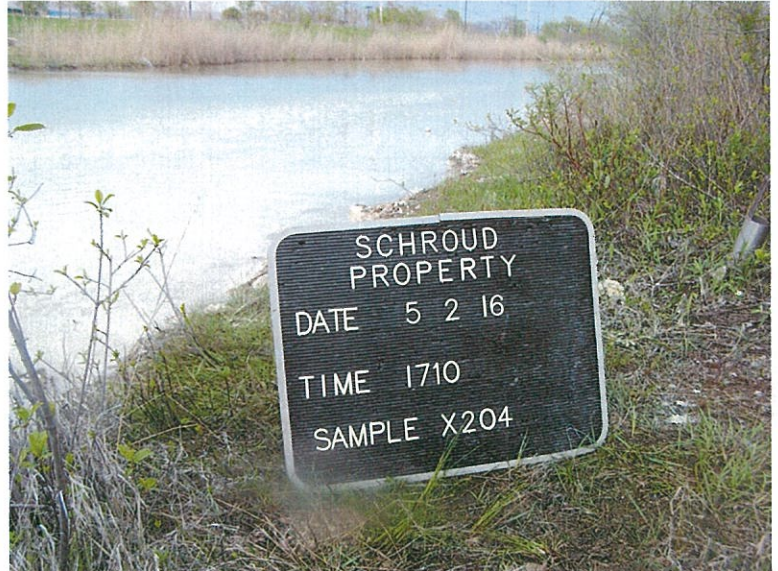
COMMENTS: X204 material was white in color and fine silty for the first 2 feet with some clayey silt with trace sand. Sample collected from 0-2 feet.

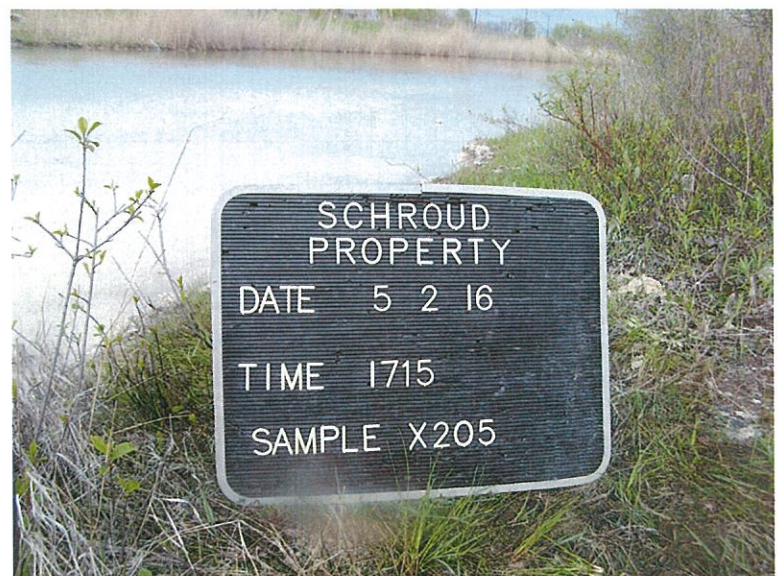
COMMENTS: X205 collected from the same location as X204 but from 2-3 feet in the fine clayey silt, gray in color with some slag material.

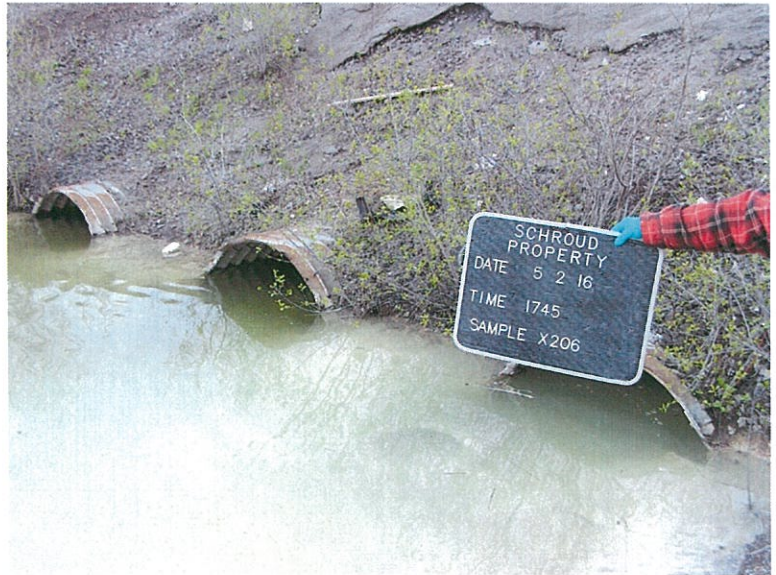
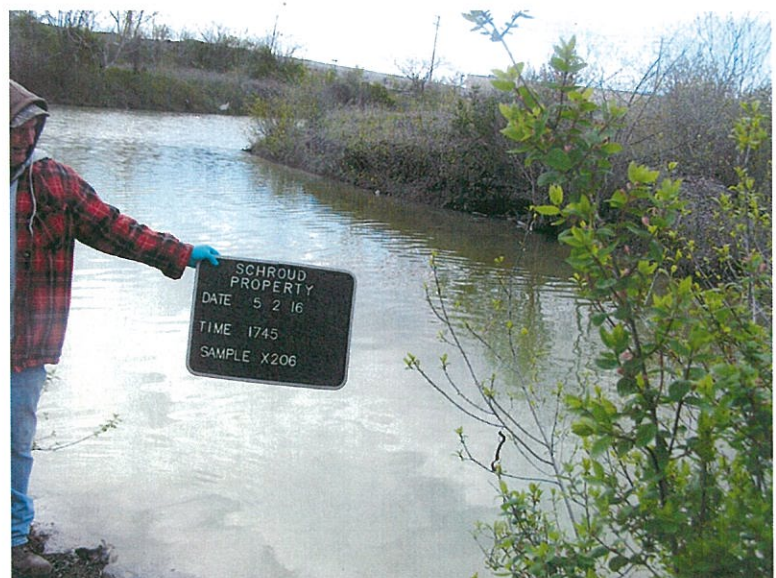
COMMENTS: X206 Collected at the culverts located on the Schroud Property on the East side. Collected on south side of the creek.

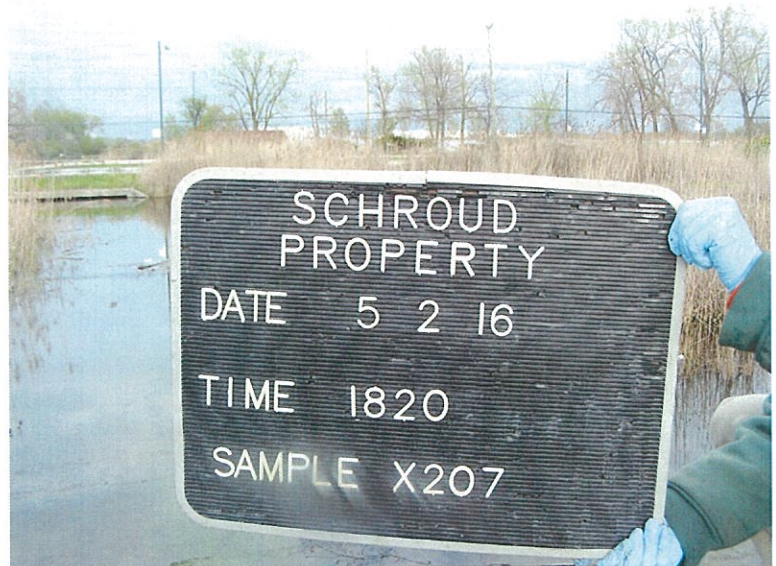
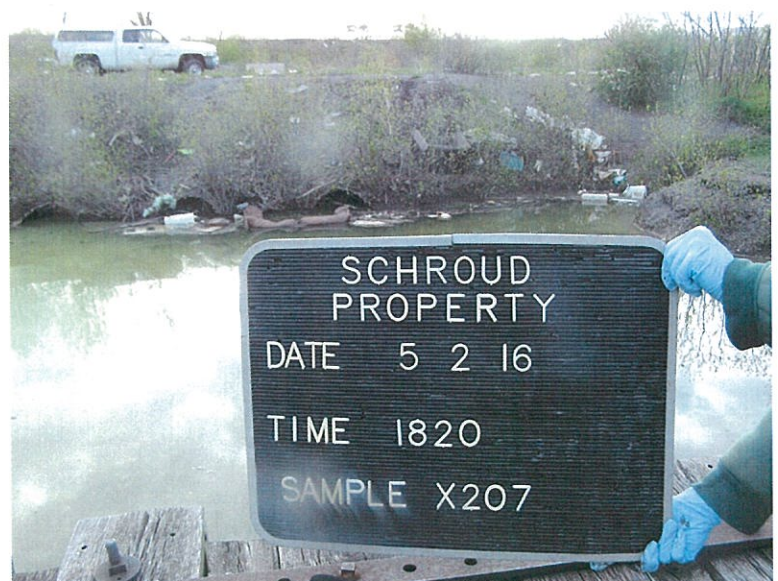
COMMENTS: X207 Collected from east side of bridge in middle of creek on east side of Schroud Property. Contained black silty clay with some fine sand.

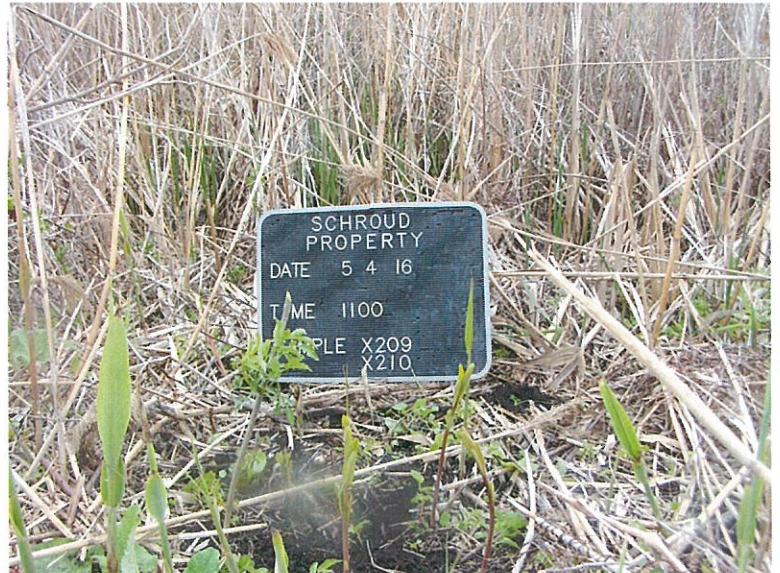
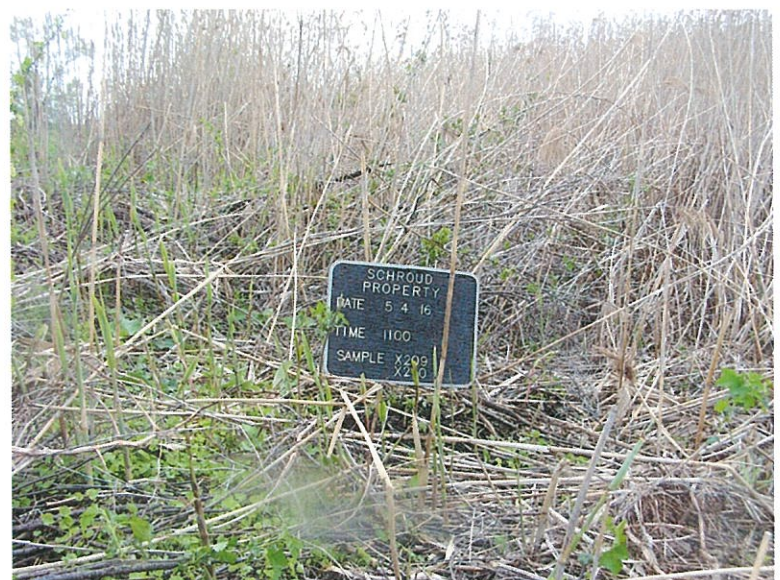
COMMENTS: Sample X209 and X210
was collected from the wetland located on
the east side of the site. Black clayey silty
loam. X210 is a duplicate of X209.

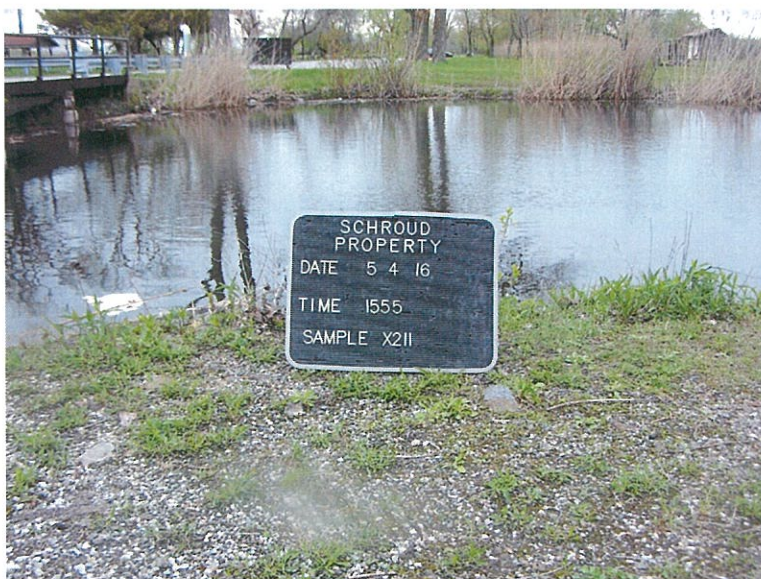
COMMENTS: Samples X211 was collected from the William T. Powers State Park. The sample was collected as a background sample and consisted of gray sandy silt.

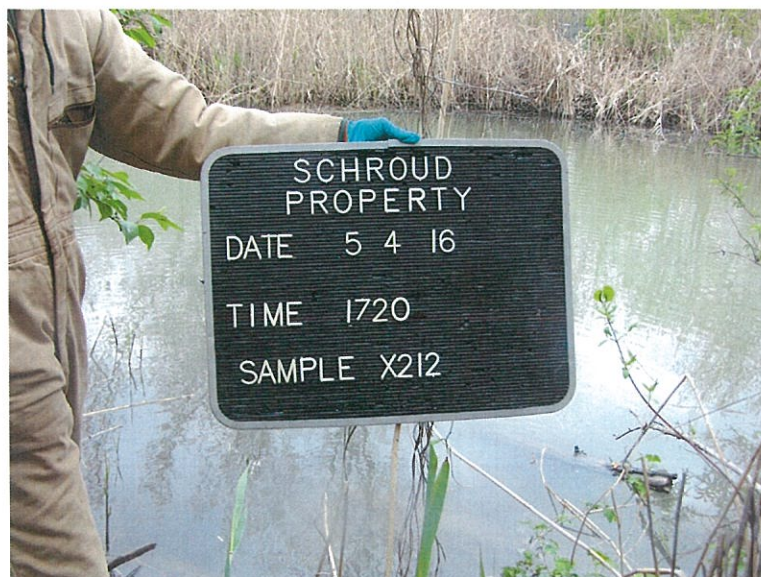
COMMENTS: Samples X212 was collected from 0-6 inches. Sample was light to gray sandy silt. Collected near baseball field.

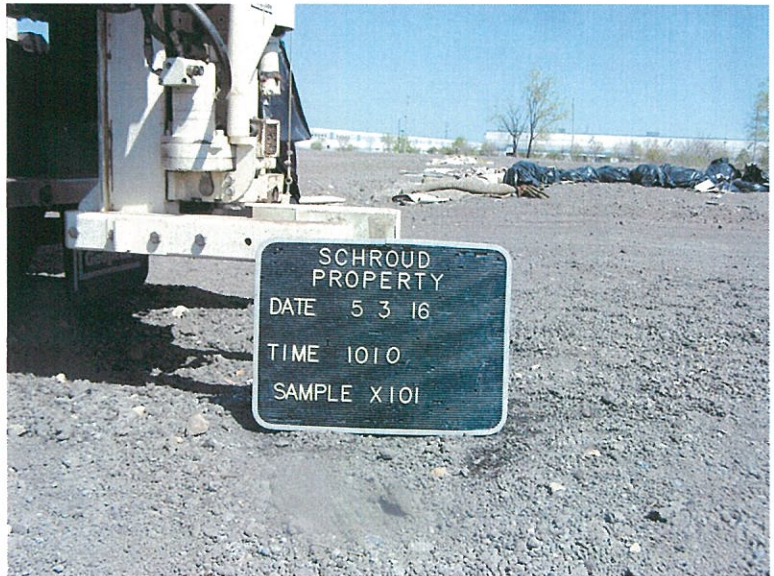
COMMENTS: Samples X101 was collected from 1 foot in the red cinder material. TCLP was collected from 13 feet from the red slag material.

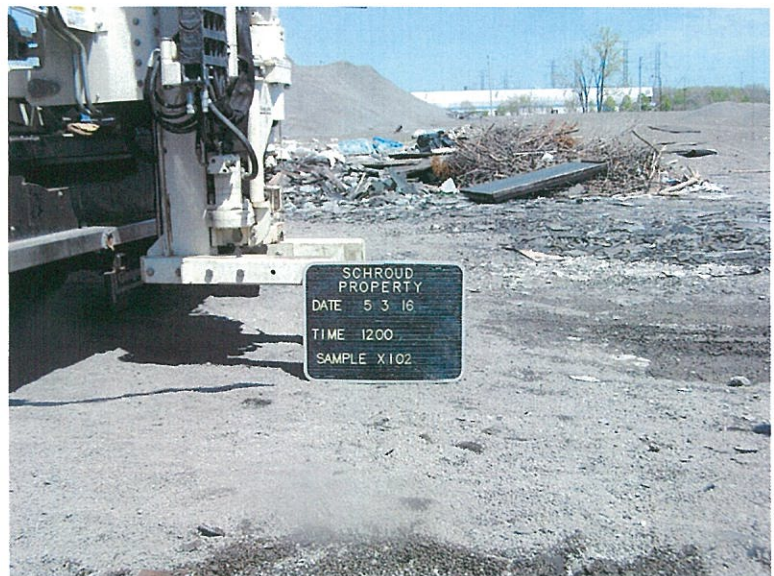
COMMENTS: Sample X102 was collected from 0-2 feet. Material consisted of black slag material with small gravel.

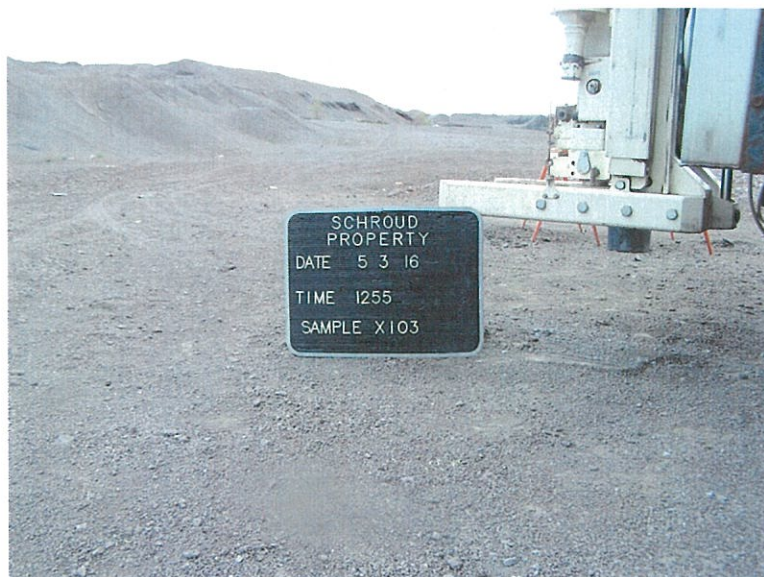
COMMENTS: X103 was collected from
4.5-6 feet in fine silty red clay, moist.

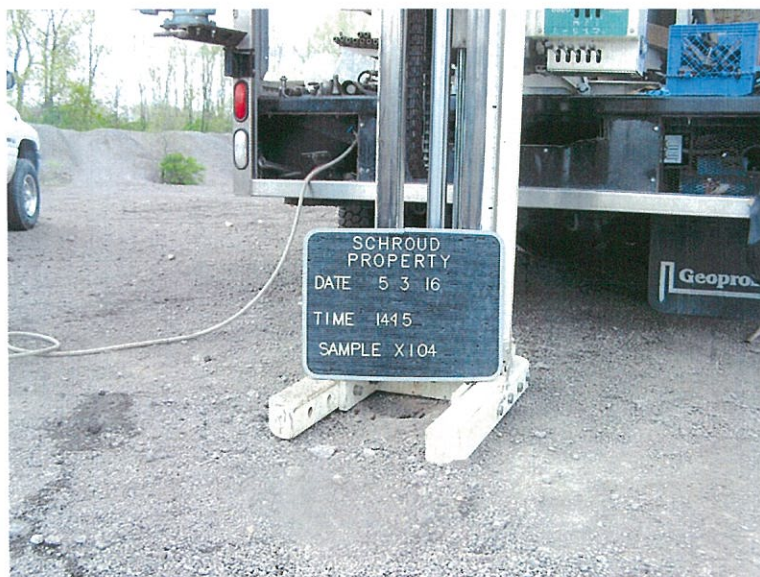
COMMENTS: X104 was collected from
0.5-1.5 from the black cindery material.
Only Hex chrome and total metals was
collected from this depth. TCLP was
collected from 6 feet in black slag with
larger rock like material.

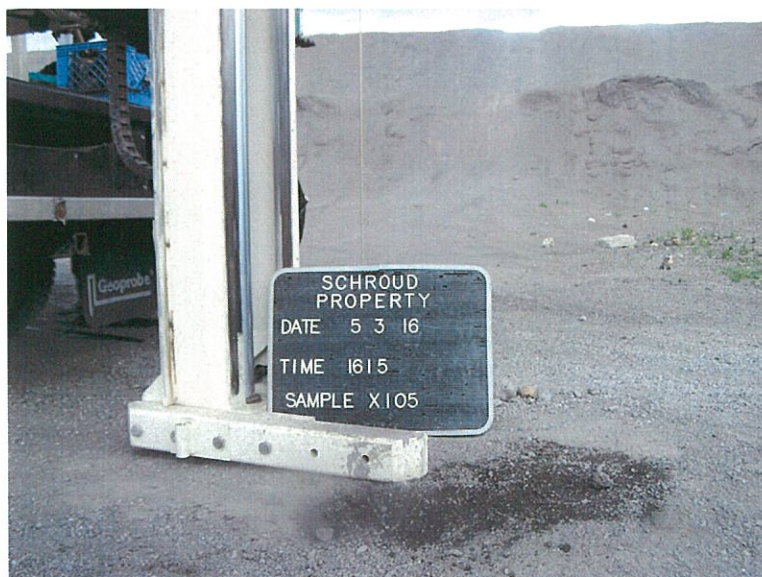
One sample, X105, was evaluated for semi volatile organic compounds due to a strong volatile odor encountered during the screening process. There was no detection on the screening instrument PPB Rae of any volatiles present although there was a strong odor. Analytical results also failed to detect any compounds of significance detected in the sample above any removal action level.

COMMENTS: X105 was collected from 0.5-1.5 feet in a mottled brown, gray and red slag material. Hex Chrome, total metals and tcip were collected from this depth and semi volatile was collected from 8.5-9.5 feet. Depth had an odor but no reading on PID.

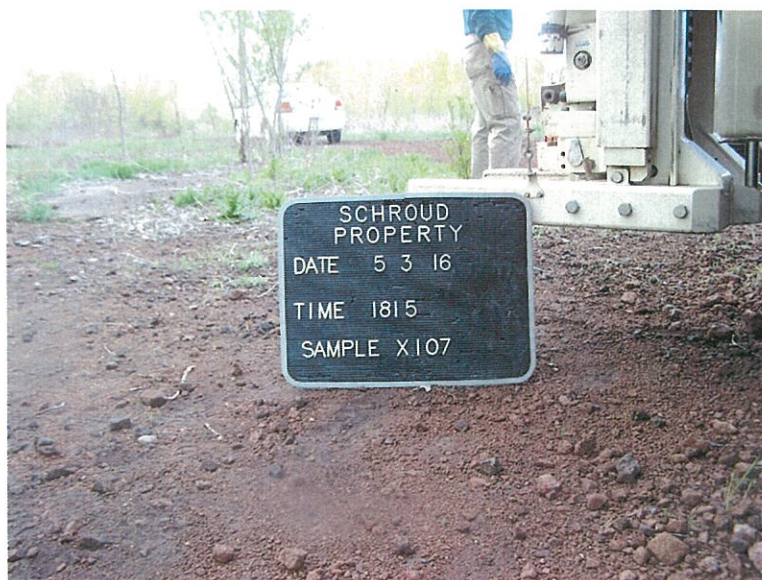
COMMENTS: X107 collected hex chrome and total metals from surface to 1.5 feet. Consisted of fine black cinder material.

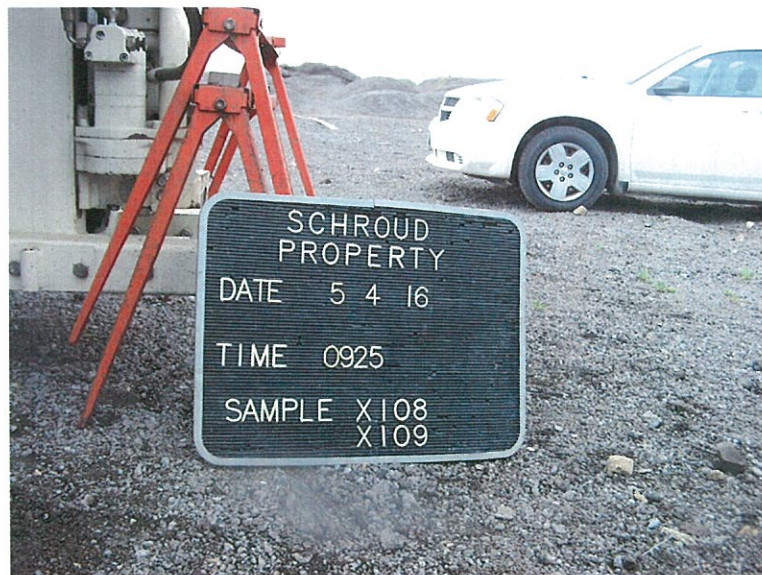
Seven soil samples were evaluated for TCLP metals to document the toxicity of the hazardous substance found in the soil samples. Samples X108 and X109 exceeded the TCLP limit of 5 mg/L for lead. The readings were 248 mg/L and 218 mg/L respectively. The TCLP results can be found in Table 2.

COMMENTS: X108 and X109 was collected from 0-1.5 for hex chrome and total metals. Material consisted of black cinders with small rocks. The TCLP was collected from 10.5-12 feet and consisted of black silt with some red material.

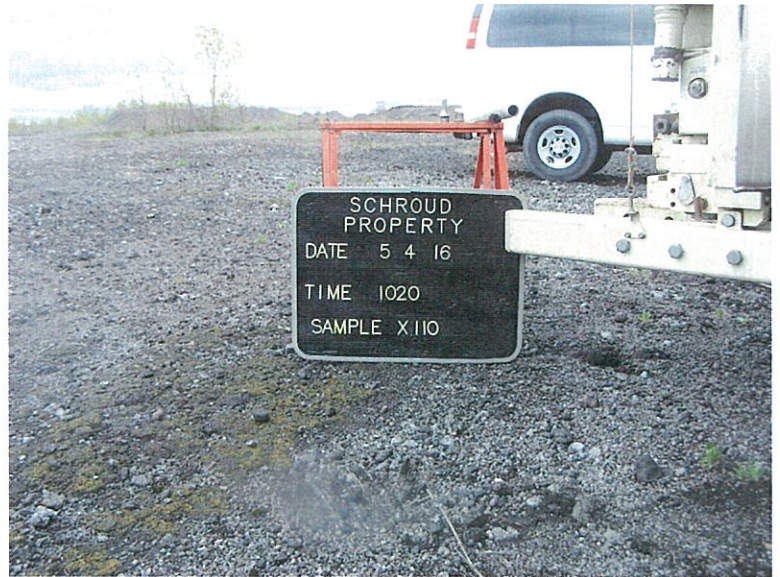
COMMENTS: X110 was collected from surface to 2 feet and consisted of gray and black cinder material. Only hex chrome and total metals was collected.

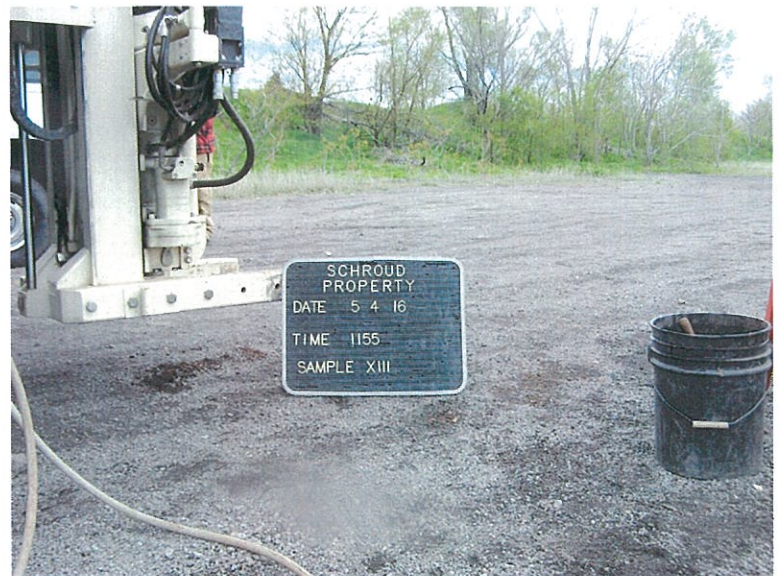
Table 3 summarizes the soil sample results collected during the SI of the Schroud Site. There were a total of 17 soil samples collected from 16 different locations. Sample X109 was a duplicate of X108. The soil samples were analyzed for Hexavalent Chromium, Total Metals, Cyanide, and Mercury. One soil sample, X105, was analyzed for Semi Volatile Organic Compounds as well due to the odor of the sample. Sample X116 was used as the background sample to compare all soil samples to and to establish an observed release by documenting a release of at least 3 times the level of the background sample. There were 22 metals that were detected at or above three times background or above a removal action level. Lead, chromium and hexavalent chromium had high levels of contamination. The highest level of lead was 6850 mg/kg found in sample X103, chromium was 4400 mg/kg and hexavalent chromium was 84.9 mg/kg found in sample X111.

COMMENTS: X111 was collected from surface to 1.5 feet. The sample consisted of black, gray and red cinder material. Only hex chrome and total metals was collected.

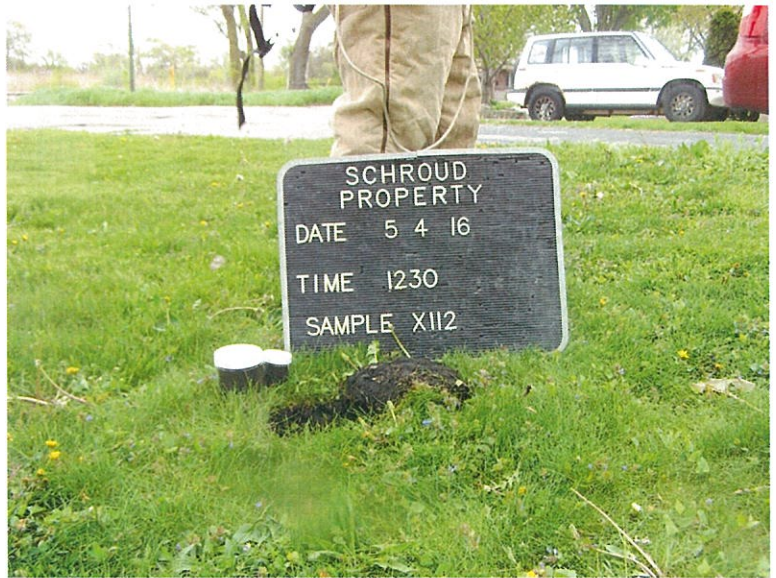
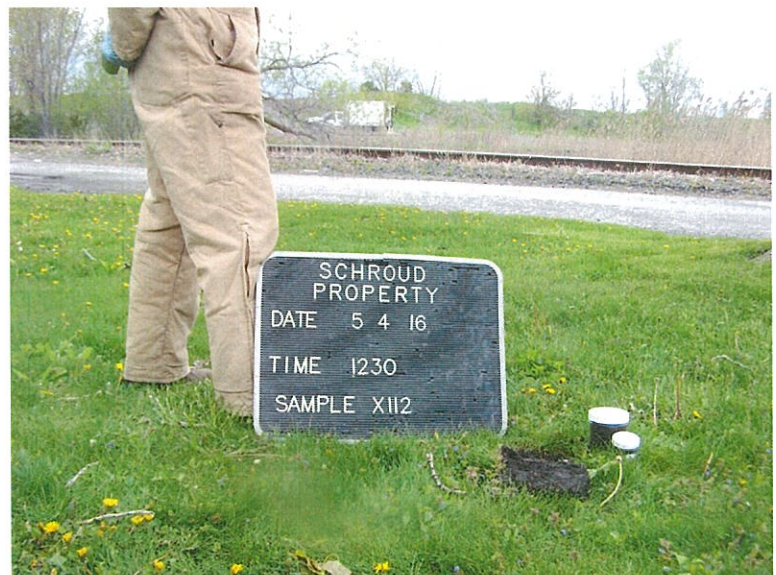
COMMENTS: X112 was collected from a residential property and sampled from the surface for hex chrome and total metals. Soil was black silty loam.

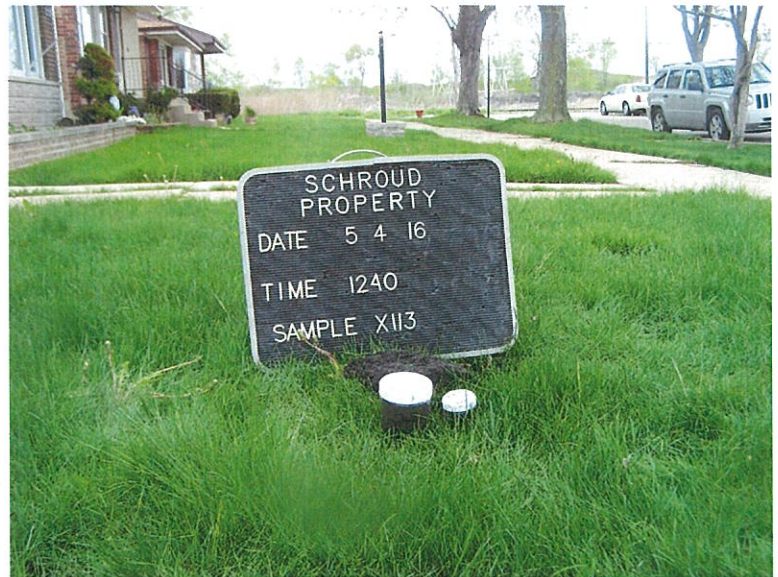
COMMENTS: X113 was collected from a residential property and sampled from the surface for hex chrome and total metals. Soil was black silty loam.

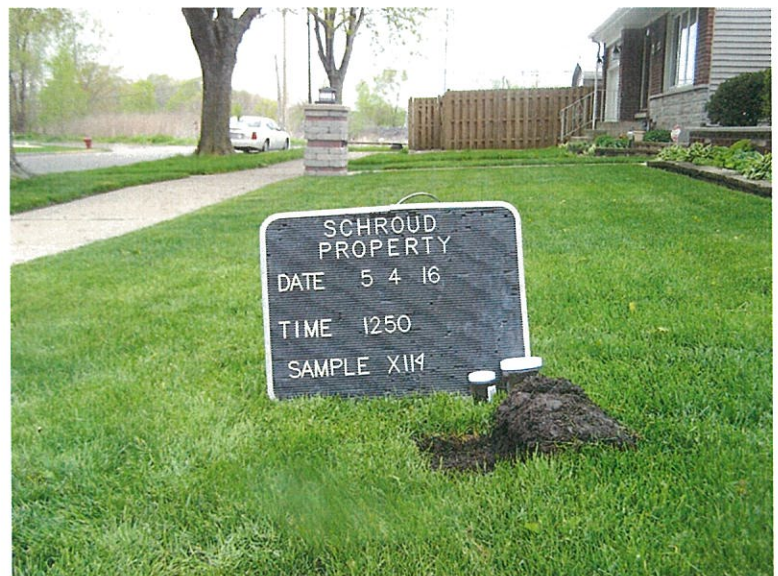
COMMENTS: X114 was collected from a residential property and sampled from the surface for hex chrome and total metals. Soil was black silty loam with some clay and sand.
